**ESTIMATED RESERVE REQUIREMENTS
FOR THE GATES AT BOULDERCREST
UNIT OWNERS' ASSOCIATION**

Prepared by Huie Reserve Reports
October 30, 2023
© All rights reserved

EXECUTIVE SUMMARY

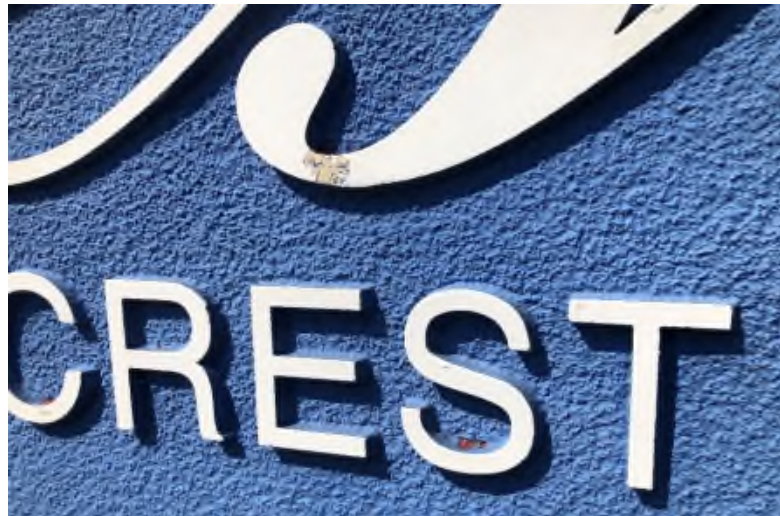
Signage - 20-year normal life. The main signage for The Gates at Bouldercrest is one large sign mounted to the steel fencing at the entrance to the property. This category funds the refurbishment and replacement of the entrance signage. The sign is made of sandblasted foamboard which has a long life if not subjected to physical abuse. It can and has been repainted since the original installation. The sign is still in good condition and could be painted again before replacement is needed.

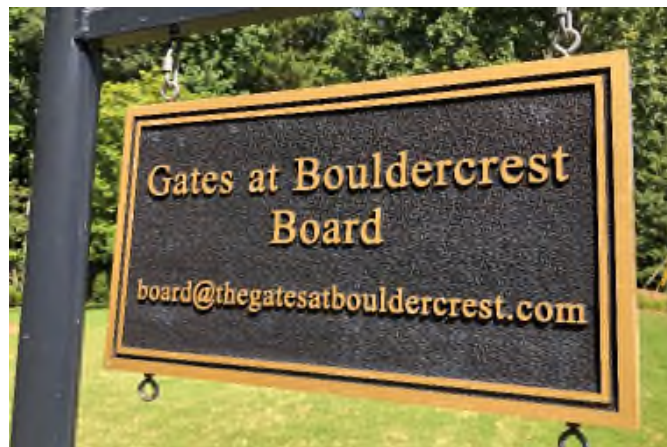
There is also a small double-sided sign hanging from a post at Bouldercrest Road. This sign is also still in good condition and can be repainted.

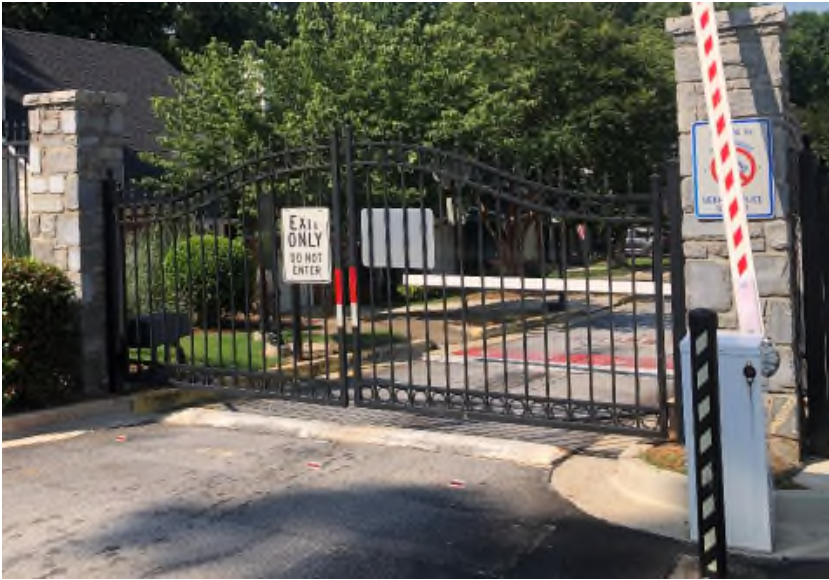
Access Control - 18-year normal life. This is a category to replace the electrical and mechanical parts of the gate system when the parts are no longer serviceable. The access system consists of a DoorKing model 1835 telephone access call box, four DoorKing model 6100 swing gate operators, and two DoorKing model 1601 barrier gate arms. According to Tim Pfeiffer of PTR Access, the contractor who has maintained the access equipment at The Gates at Bouldercrest since 2018, your system is in good condition.

The swing gate operators have battery backup but as the operators age, the batteries lose efficiency and may fail. In addition, the new DoorKing operators no longer have built-in battery backup so a separate unit, called an Inverter, must be added at a cost of about \$2200. There are other manufacturers of swing gate operators that do have built-in battery backup.

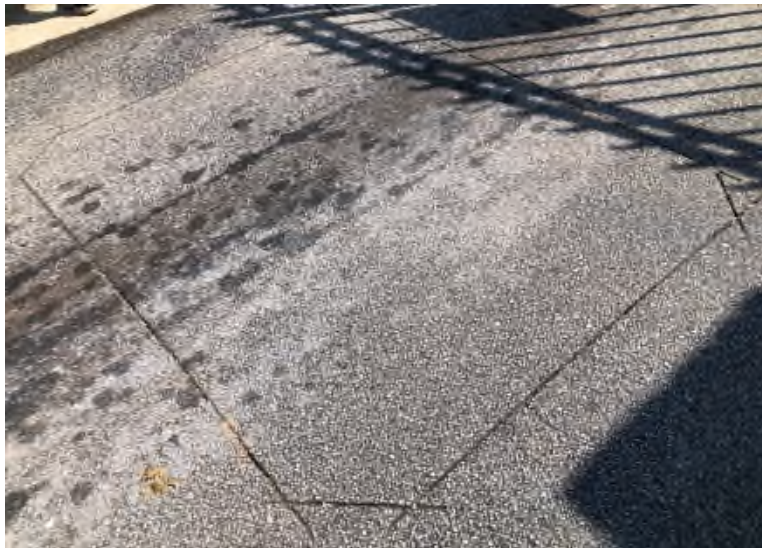
There are safety loops inside and outside of the gates so that the gates will not close on vehicles that stop in the swing-path of the gates. On the exit side, a safety loop activates the exit gate operators as a vehicle approaches the gate. When gate systems are installed during the initial construction of a property, safety loops are often installed under the topping layer of asphalt so they are not visible. If a safety loop goes bad, a replacement loop is installed by cutting a groove in the asphalt pavement surface into which a new loop is inserted. Then the groove is filled with a black sealant.

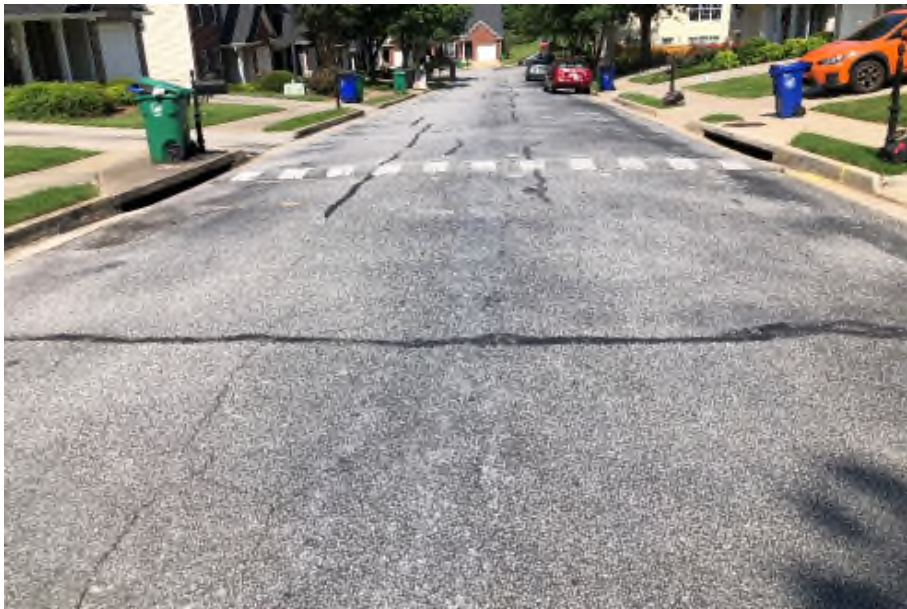
Asphalt Pavement - 28-year normal life. This category and the next provide funding for the asphalt streets at the property that are the responsibility of the Association. With a gated property, all of the streets at the property are owned by the Association, so the repair and repaving of those streets is the responsibility of the Association. This category covers the repaving of the asphalt pavement when it reaches the end of its life.

The typical construction of a street is compacted soil with four to six inches of well compacted base (i.e., crushed granite) and then asphalt layers totaling three to four inches. The durability of asphalt is determined at least as much by the strength and stability of the soil and base as it is by the quality of the asphalt pavement. The streets at The Gates at Bouldercrest are in good to

fair condition. They were probably built to same design as public streets and could have a longer than normal life.

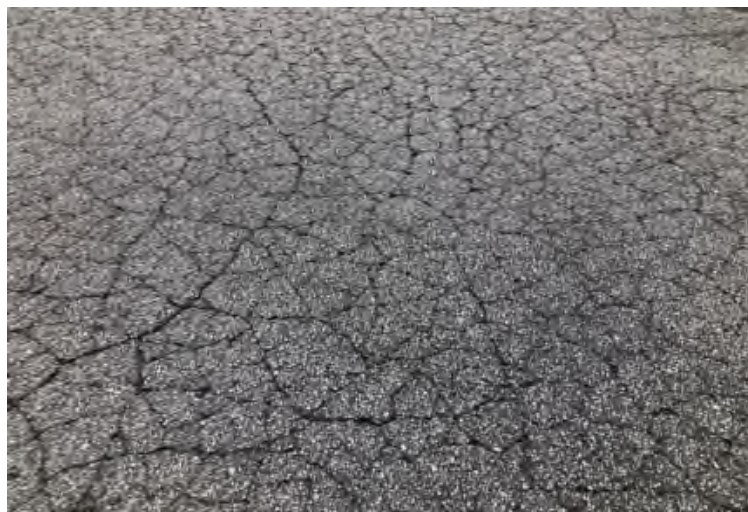
With normal asphalt deterioration as the large cracks intersect, problem areas develop. The problem areas can be seen because they are cracking in a pattern known as “alligating” because of the resemblance to the pattern on an alligator’s skin. There are several areas of alligating at The Gates at Bouldercrest streets, particularly at the cul-de-sac near 1201 (seen in the next photo). The cracking is undesirable and will result in problems over time. In addition, when pieces of the asphalt chip away along the cracks, it indicates that the asphalt pieces are flexing when vehicles drive over it and could indicate a problem with the base under the asphalt.

The typical method for making asphalt repairs is to saw cut and remove the damaged sections, check for and correct the underlying issue and then place new asphalt. It was noted that there are few repaired asphalt areas indicating that the pavement has performed well.

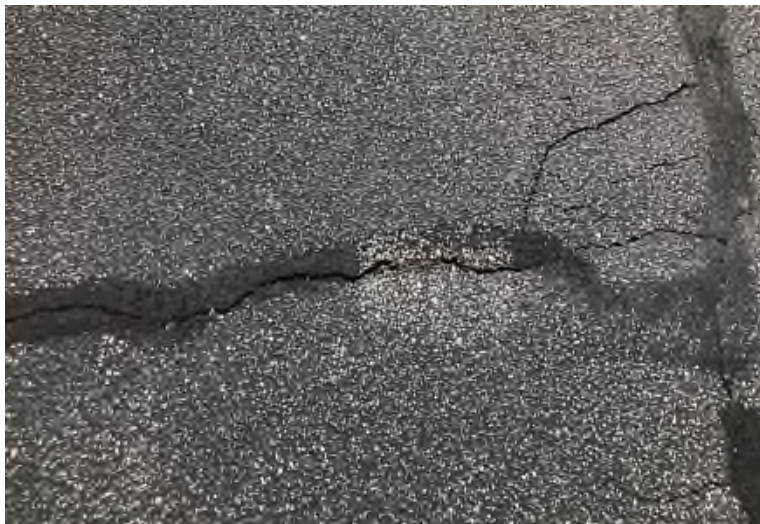
Crack filler was used at The Gates at Bouldercrest to fill in some of the cracks (see the next photo). Crack filler can be effective for cracks that are greater than ¼” wide but will not penetrate narrower cracks. Crack filler will not prevent further cracking. In addition, seal-coating does not properly adhere to crack filler, so the seal-coating wears off areas where crack filler was applied leaving a cosmetic issue.

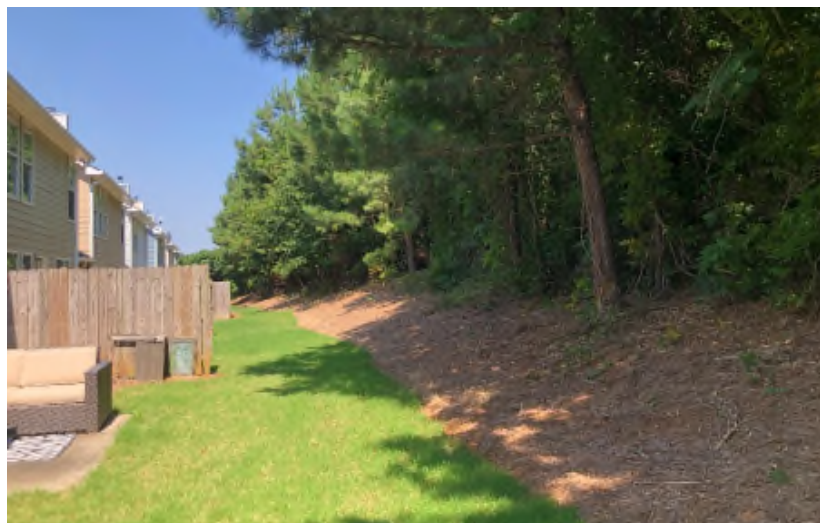
The junipers in the area behind some of the buildings on the north side of the property centered at 1328 were removed because they were planted too close to those homes and had grown too large.

The grass behind the units was being shaded out, and the branches were overhanging the patios and fences. This kind of long-term, large-scale work is a Reserve expense. The junipers on the other side of the property are performing well and not interfering with the grass or nearby homes.

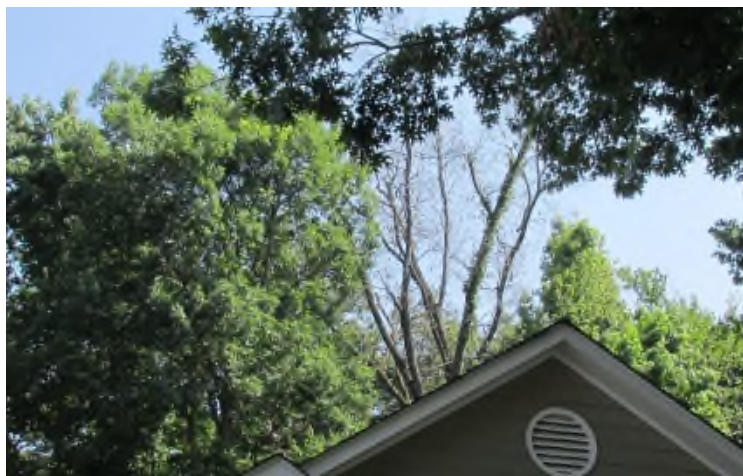
One issue of particular relevance for The Gates at Bouldercrest is trees. Tree removal can be a large expense, particularly with large trees or trees in hard to access areas. It is unlikely that tree removal could be funded by the Operating Account, so it is funded by this category of the Reserve Fund. There is a large number of trees at The Gates at Bouldercrest. A significant amount of money has been spent on tree removal, and this will continue to be an issue. At the time of our site visit, the removal of several trees was scheduled. A dead tree behind 1350/1354 can be seen in the next photo.

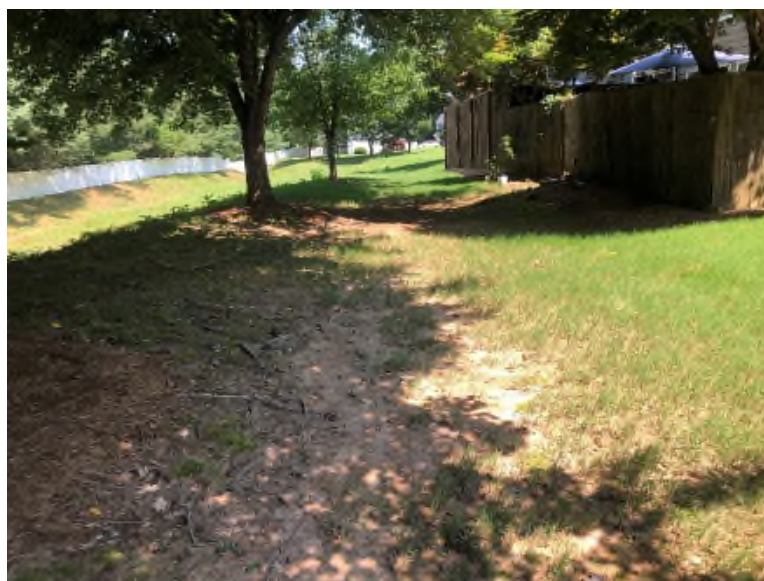
The next photo shows the area behind 1504 where the shade from a nearby maple tree has caused the grass to retreat. Erosion issues develop where there is no groundcover.

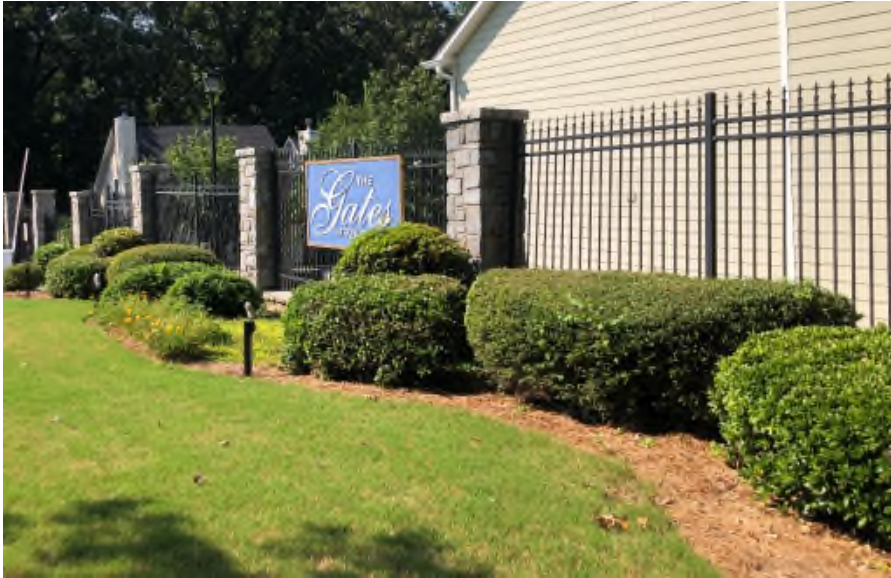
The plant material at the property entrance contributes to the curb appeal of the property. The addition of seasonal color would be an Operating expense, but the replacement of the shrubs at the entrance would be a Reserve expense. The plant material currently at the entrance is well tended and in good condition, but you will want to update the plant material at some time in the future.

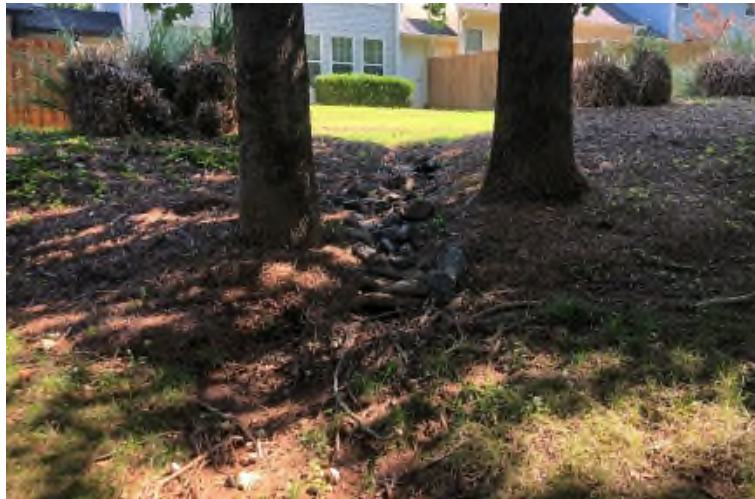
One of the largest drainage issues that is currently a concern is the issue in the middle island of the property. A large amount of water is coming from the homes near 1269 and is causing some erosion as seen in the next photo. It was reported that one of the homes in this area has a leak that is yet to be identified.

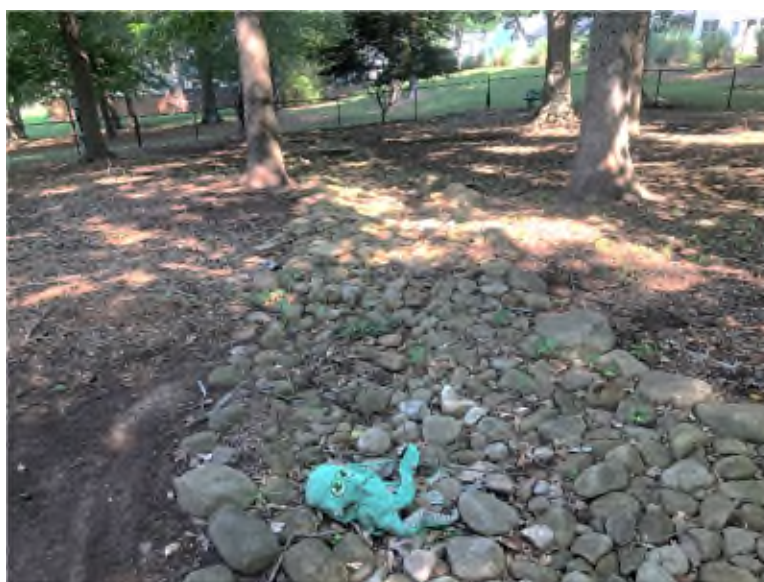
The large amount of water coming from this area washes through the dog park area. A significant portion of the wood mulch in the dog park has been washed away. There is a rock-lined swale (i.e., channel) in the dog park (see next photo). This was a good concept, but it was not constructed correctly. The swale starts just inside the chain-link fence so the leaves and debris that wash down become lodged in the fence and block the swale directing the water away from the swale. The swale needs to start several feet outside the fence and be deeper so that the water (and debris) flow under the fence. (It is understood that this may be an issue with dog retention but it may be possible to install a couple of vertical bars that will not obstruct the flow and also retain the dogs.)

There is a plan to collect the rainwater from the gutters and yard drains of the homes on the north side of the park and then carry the water down the hill in incrementally larger pipes. Proposals are currently being solicited for this work. Along the south side of the park there is a berm (i.e., hump) that collects the stormwater and directs it down to the lower area where a large stormwater inlet collects the water and then pipes it under the road and, eventually, into the detention pond. The berm prevents flooding in the rear areas of the homes below it so any problems with the berm should be quickly addressed.

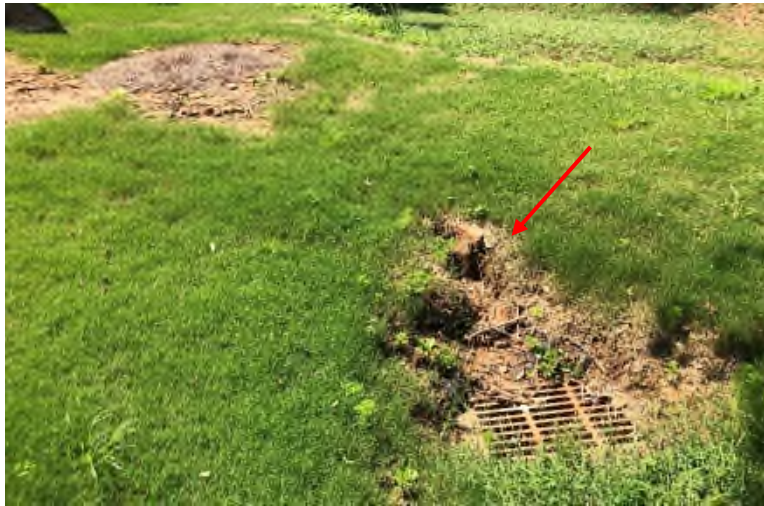
The next photo shows the area just above the drainage area above the detention pond and near the back of 1504. Erosion is developing that should be addressed.

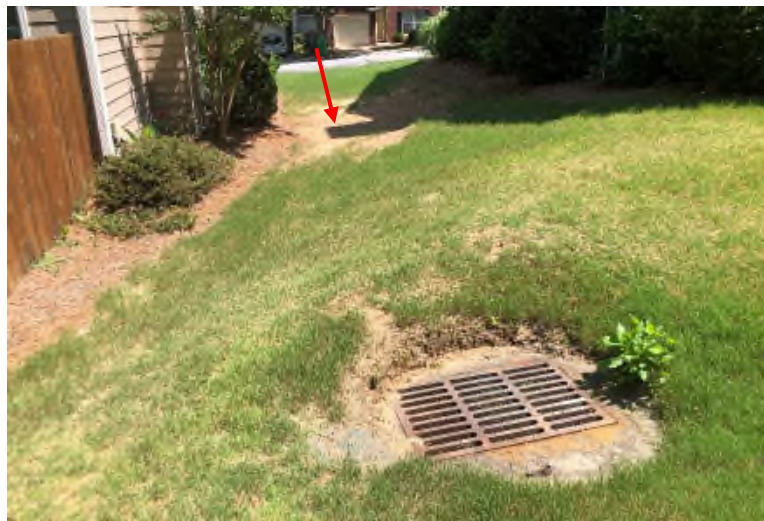
The area beside 1476 can be seen in the next photo. Note the bare area. Several similar areas were noted in locations where the two adjacent homes are on different elevations. Given the healthy condition of the rest of the turf in these areas, it should be possible to establish a satisfactory stand of grass or some other ground cover to prevent erosion.

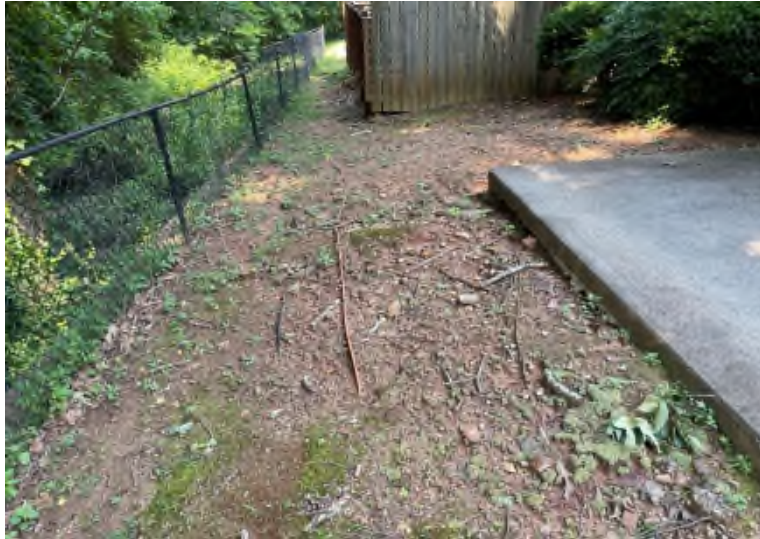
One area of concern for a limited number of homes is sheet erosion (where water flows over soils as a sheet evenly eroding the soil) behind homes where there is intense shade. This issue is confined to the rears of homes on the south side of the street near the entrance, primarily 1371 to 1383 and, to a lesser degree, behind 1355 to 1367. The next photo shows the area behind 1371 to 1383.

There is essentially no ground cover and the soil over the (inadequately buried) cable wire has eroded away. There is a retaining wall on the far side of the chain-link fence. The fence acts as a guardrail but has been replaced because leaves lodge in the base of the fence that catch the eroded soil so that the soil builds up on the near side of the fence and cause the fence to lean. The Association is having an engineer examine the wall to ensure that it is still stable and then suggest a way to raise the height of the wall so that this back area can be brought to a suitable slope. Then shade-tolerant ground cover can be established.

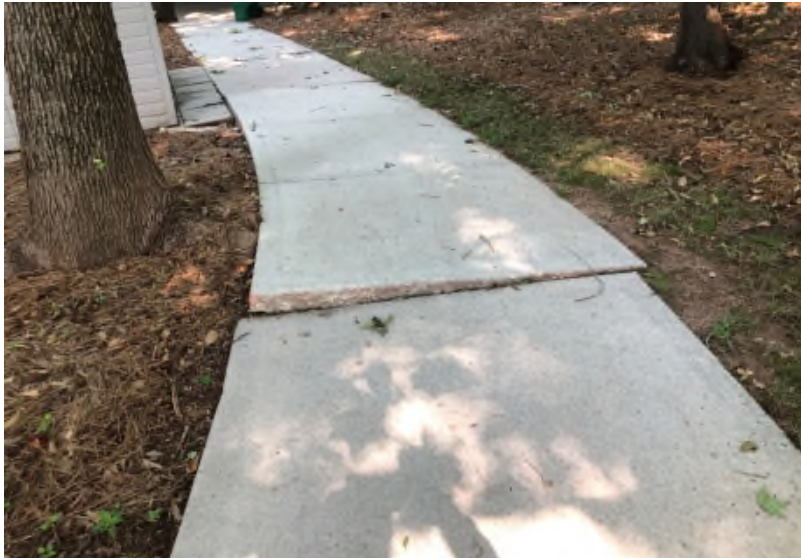
Uneven sections of concrete can create a trip hazard, such as the one seen in the next photo. This can be caused by settlement in the area, and it can also be caused by heaving from nearby

tree roots. Due to the proximity of trees to the section in the next photo, it is assumed that this was caused by heaving.

Sometimes this can be remedied by gridding down the uneven edges to eliminate the trip hazard, but this would be a temporary fix unless the underlying cause for the problem is corrected. Whenever sections are replaced due to tree roots, the root should be pruned so that it is no longer under the section of concrete. If the tree is close to the sidewalk, as in the photo, there are options- remove the tree; relocate the sidewalk; put the sidewalk back without addressing the tree with the understanding that the sidewalk will soon be a problem again; or build an elevated (wood) bridge to span the area. Unless the tree is an important feature, removing the tree is the best approach.

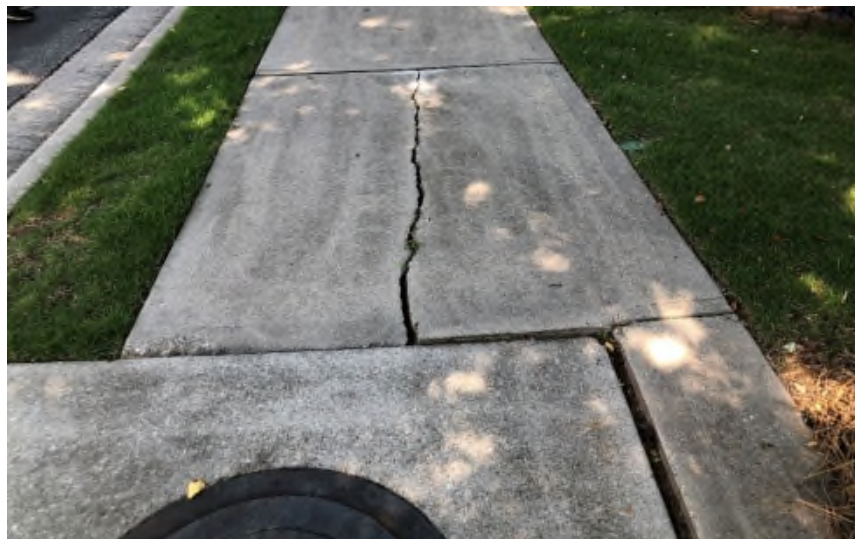
Several sections of sidewalk are cracked (see the next photo). Minimal hairline cracking is often a minor cosmetic issue. The crack in the next photo is a wide crack down the entire section.

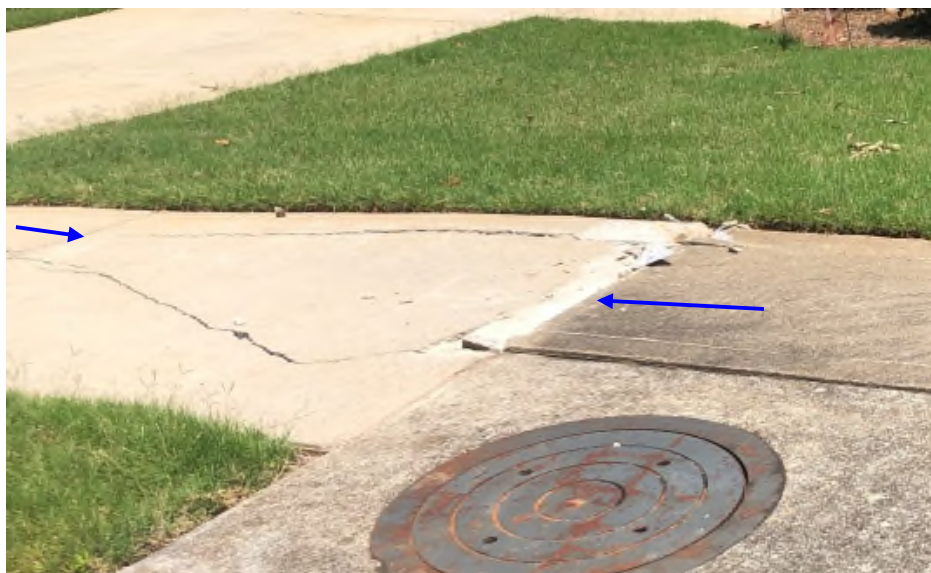
One section of sidewalk was cracking in such a way that appears to be crushing due to pressure from each end (indicated by the blue arrows). We see a tremendous number of sidewalks and have not seen an issue like this. It could be due to thermal expansion of the concrete. The strength of this section of concrete could be substandard, but it is not worth having it tested. The best approach is to replace the section and include an expansion joint between the new section and one of the two abutting concrete sections.

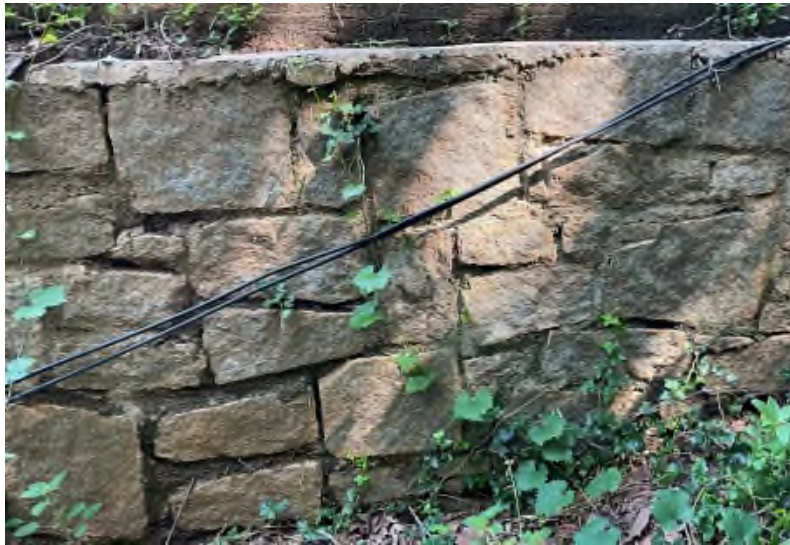
Two of the retaining walls at The Gates of Bouldercrest (the two walls behind the homes at the entrance on the south side and the wall beside 1374) are gravity walls. This means that the weight of the stones is sufficient to retain the soil. The walls have mortar joints, but these are not like the mortar joints in a brick wall where the mortar glues the brick together. The mortar is mixed with relatively little water so that it is “dry” and is used to separate the stones. This dry mortar is very porous and will sometimes crumble and fall out. It was noted that the mortar in some of the joints is missing. The mortar joints should be tuckpointed (i.e., replaced), but the missing mortar does not affect the structural integrity of the wall. If the joints are filled, this same type of dry mortar should be used so that the appearance of the wall is not changed.

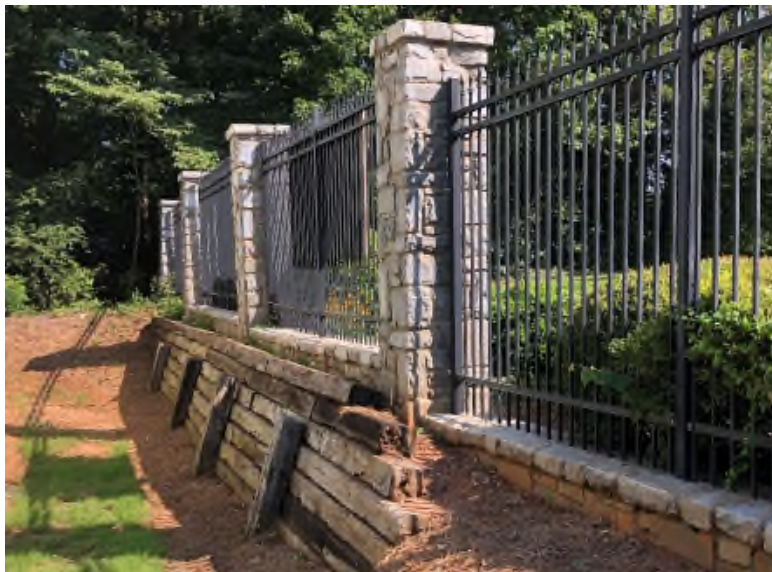
Part of the stone fence structure is leaning due to inadequate support. Funding is included in 2024 to correct this.

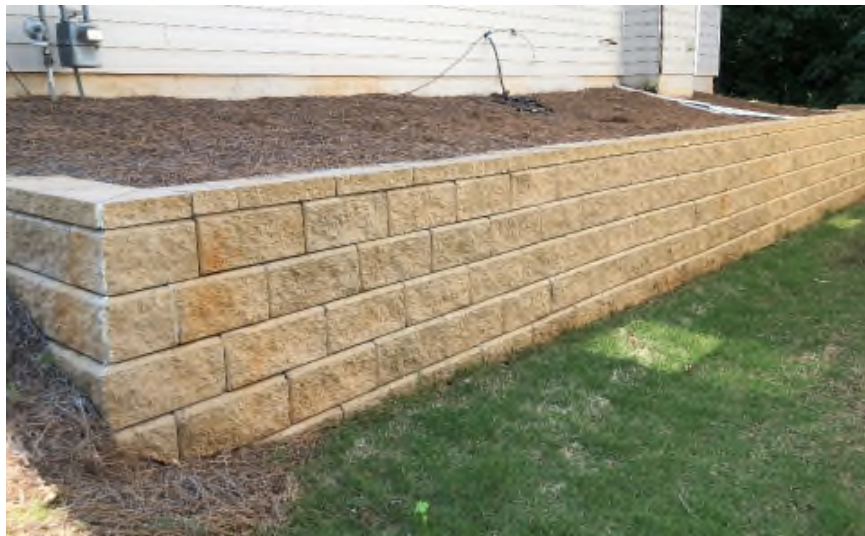
There are several modular concrete block retaining walls at the property. These walls should have an indefinite life, but any necessary repairs would be covered by this category. The replacement of the wood retaining walls is covered by the **Wood Retaining Walls** category.

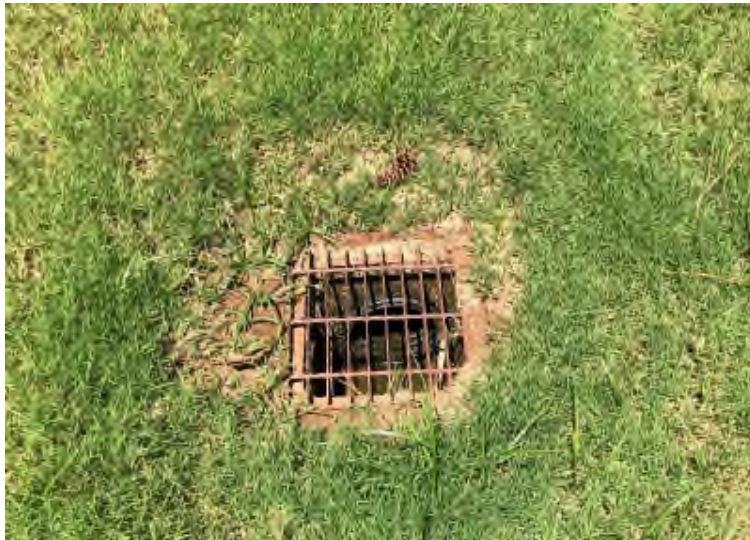
There are many drains in landscaped areas. The **Drainage** category covers issues with surface drainage, but repairs to the buried drain lines would be covered by this category. Infrastructure issues are relatively rare in the first fifteen to twenty years of a property but tend to be more common thereafter.

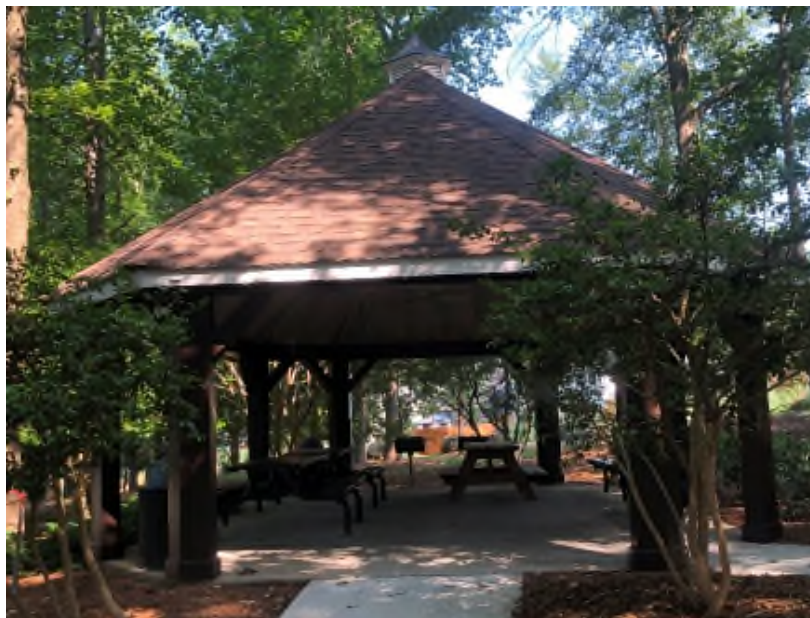
Gazebo – 12-year normal life. This category provides a fund to repair and repaint the gazebo structure as well as to replace the architectural shingle roofing. The gazebo was painted in 2019 and the current roofing was installed in 2020. The deteriorating wood was replaced and touch up painting was done this year.

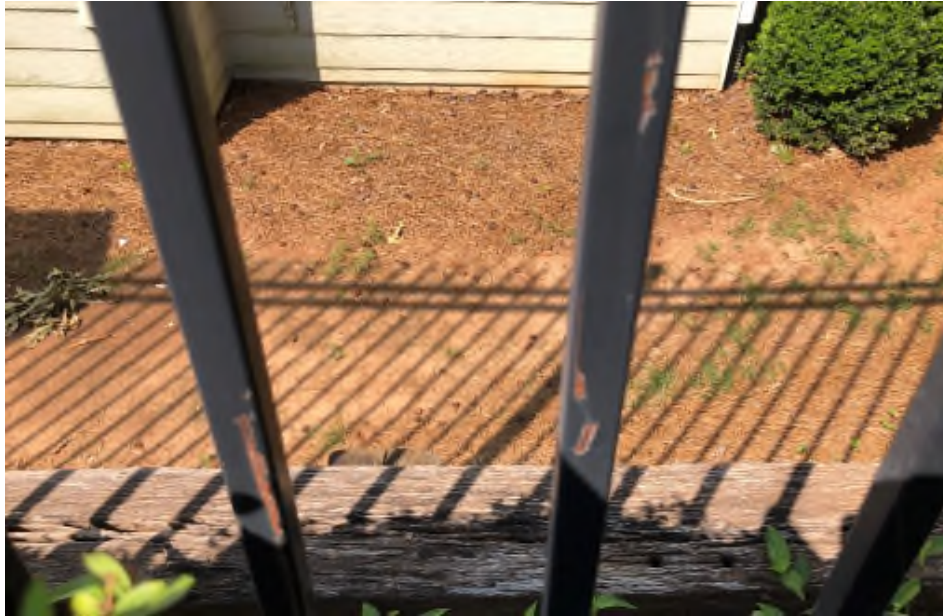
The steel fencing at the entrance is still in good condition and could have a long life if protected from physical abuse. There are spots where the powder coating on the fence has been chipped, and the steel below is rusting (see the next photo). This fencing can be treated and painted to improve the appearance and prolong its life. If painting is desired, the painting and the cost

should be included with the painting at the gazebo. It may be necessary to paint every six years to obtain the best result.

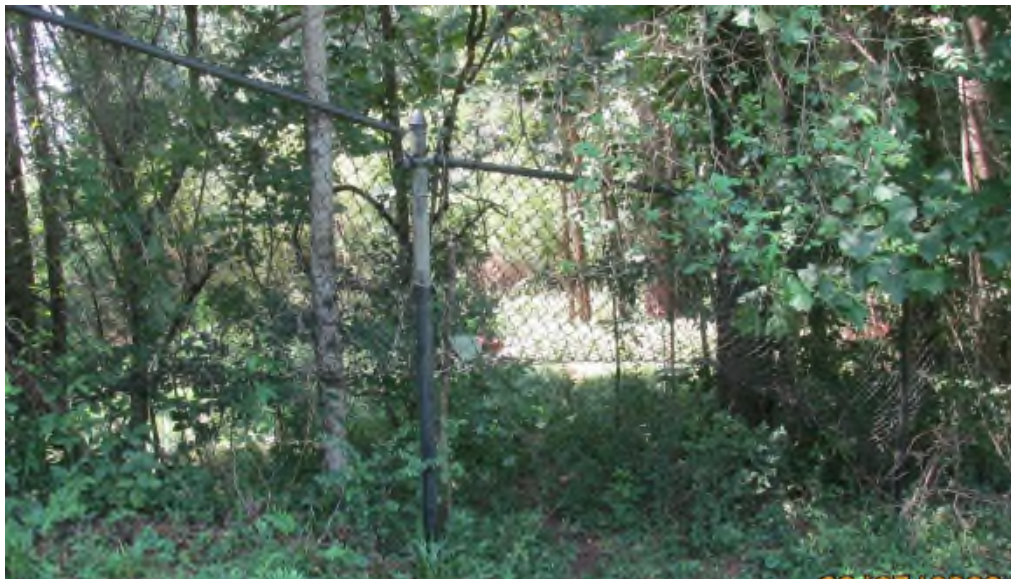
The vinyl-coated chain-link fencing in various locations of the property is in good condition for the most part. There is chain-link fencing at the retaining wall behind the first four homes on the left when entering the property, on top of the retaining wall beside 1374, at the dog park, and at the detention pond and upper drainage area. The chain-link fencing that extends from the end of the vinyl fencing into the detention pond is barely visible due to the large amount of vegetation growing around and through it. A portion of the chain-link fencing on the south side of the detention pond is damaged (see the next photo).

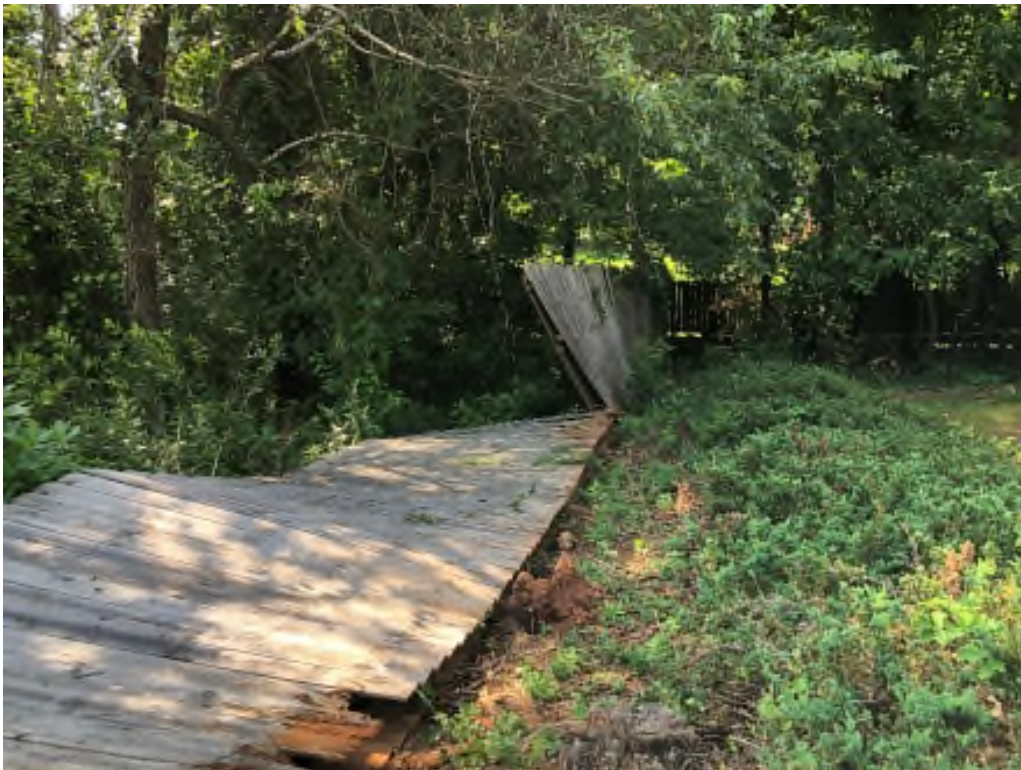
In some places, the fencing still in fair condition, but it is generally in need of replacement. The 8-foot wood fencing on the north side of the entrance has failed but is still standing because it is leaning on a nearby tree. A large portion of the wood fencing on the south side of the entrance has fallen over, and the portion that has not yet fallen over is leaning. These sections of fencing are scheduled to be replaced this year.

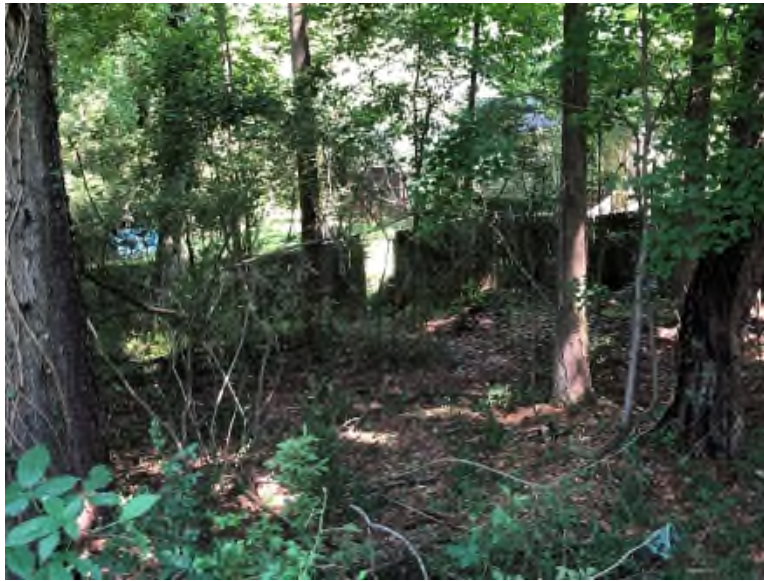
The 6-foot fence is less top-heavy and is generally still standing but has deteriorated and also damaged by falling tree limbs (see next photo).

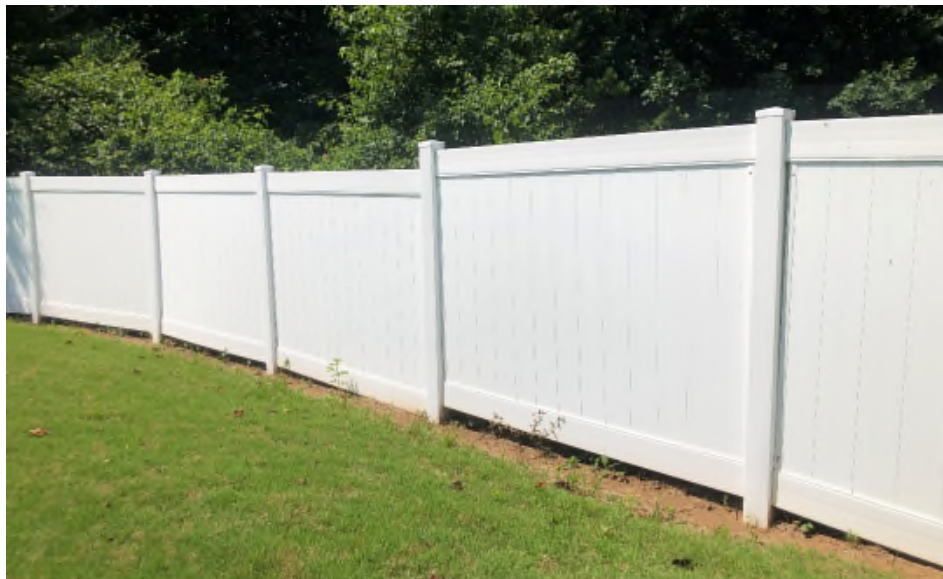
Vinyl Fencing – 35-year normal life. This category provides funds to replace the 728 LF of vinyl fencing at the detention pond area. The fencing runs in front of the detention pond area and then turns to run beside the upper drainage area. The fencing is in good condition, but there are some sections that have become misaligned due to soil movement or dingy due to the shade and plant material. The fencing can be washed with an environmentally friendly cleanser. The alignment can also be addressed but it may require digging up and re-setting some of the posts.

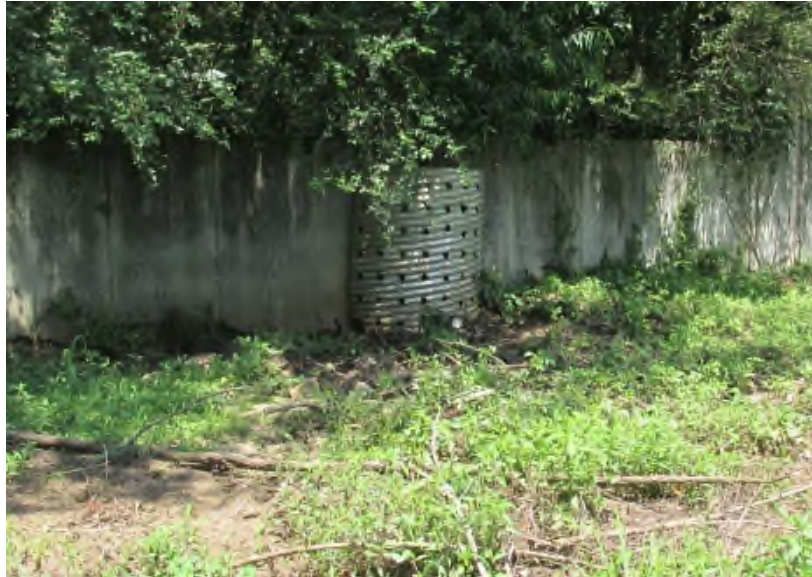
Many detention ponds have a large concrete box-shaped outlet structure. The stormwater in the detention pond enters the structure through one of two or three outlet openings and then is piped from the outlet structure to the normal path of the water, generally to a creek like the one below your property. The Gates at Bouldercrest detention pond does not have a concrete outlet structure. Instead, there is a horizontal notch in the concrete wall where water drains from the pond into a low area where the water meanders down to the creek below. The notch has a half-round perforated metal pipe placed in front of it (see the next photo) to let water out but act as a filter to keep trash and debris in the pond. The filtering is good for the environment but requires the debris to be removed on a regular basis so the system works as intended.

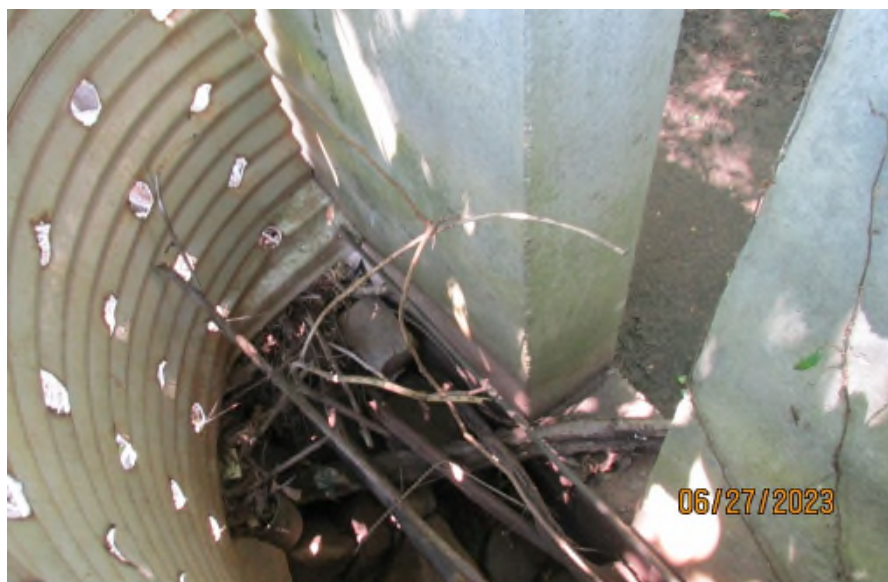
There was some debris inside the half pipe that should be removed, but the notch was not obstructed.

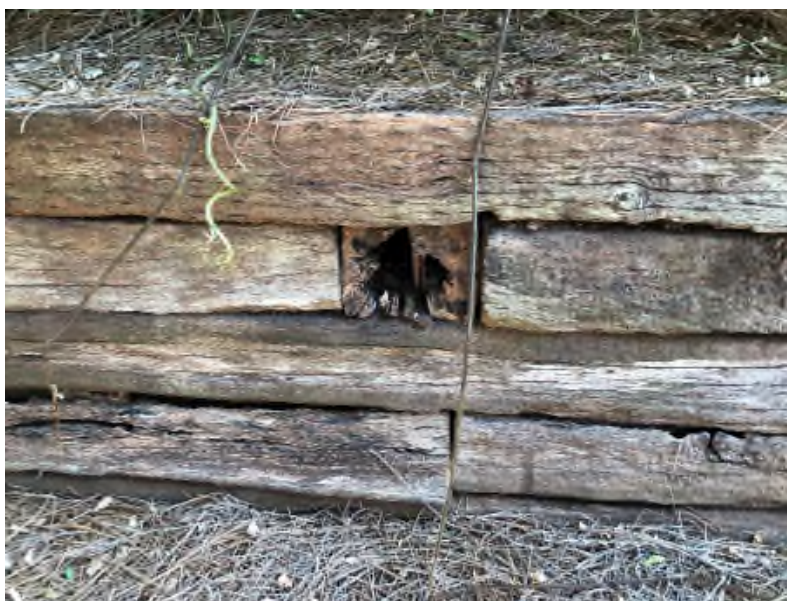
Wood Retaining Walls – 24-year life. This category covers the replacement of the wood retaining walls at the property. There are twenty-nine existing crosstie retaining walls that need to be replaced. Only two are over three feet tall. Most of the remaining walls are small, and replacement is not urgent. The walls could be replaced with new timber walls, but the Association has replaced similar walls with modular concrete block walls. The advantage of modular block walls is that they have an indefinite life and should only need minor periodic repair (covered by the **Infrastructure** category). If the walls are replaced with wood walls, those wood walls would need to be replaced again. If the walls are replaced with modular block walls, this category can be eliminated.

If there was soil pressure behind the walls, reinforcement material (i.e., geogrid plastic mats) would be needed that would attach to the wall and extend back into the soil behind the wall. Where there is no such pressure (as seems to be the case in the vast majority of the walls), these walls can be built as gravity walls requiring only a heavier type of modular block.
