**ESTIMATED RESERVE REQUIREMENTS
FOR THE GATES AT BOULDERCREST
UNIT OWNERS' ASSOCIATION**

Prepared by Huie Reserve Reports
October 30, 2023
© All rights reserved

EXECUTIVE SUMMARY

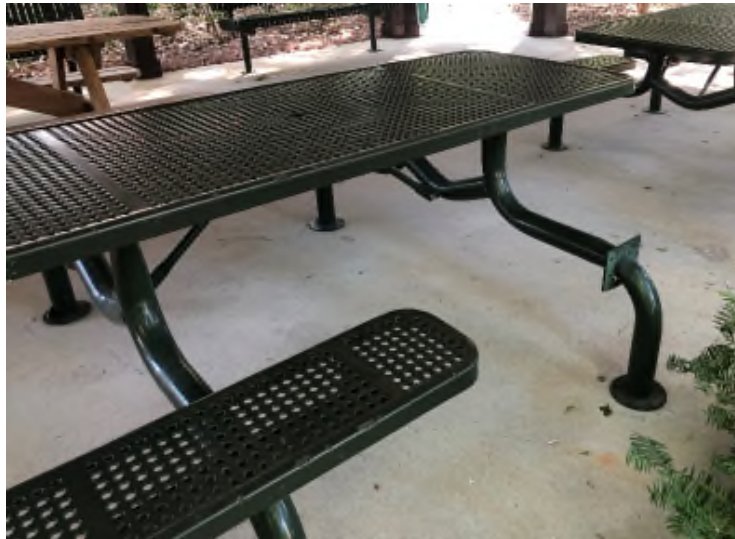
This category includes an allowance for the two plastic-coated picnic tables, the two plastic-coated benches, the wood picnic table, and the two charcoal grills at the gazebo. It was noted that one of the seats from one of the plastic-coated picnic tables was missing (see the next photo). The two benches at the dog park and the picnic table outside the dog park fencing are

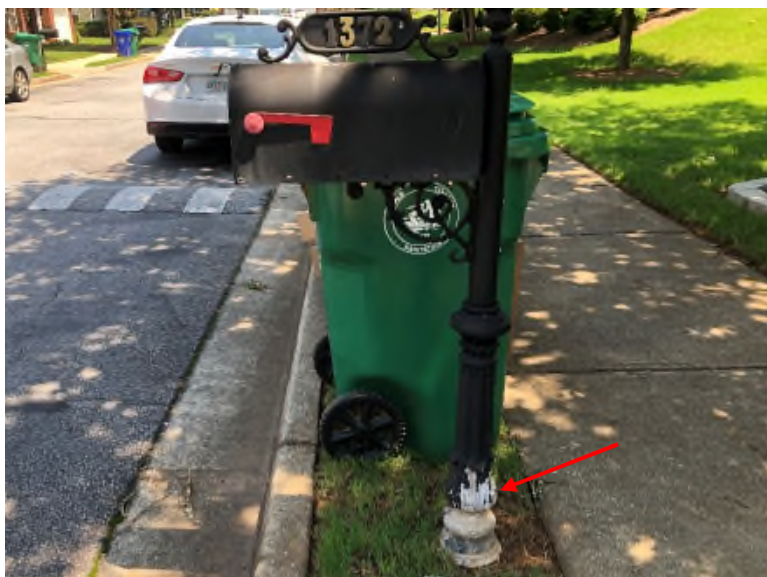
Mailboxes – 20-year normal life. The Association is responsible for the replacement of the mailboxes and the supporting posts. The structural part of a post is an aluminum pipe that has a cast aluminum decorative base and a cast aluminum decorative bracket supporting the mailbox.

The posts have a very long life if not hit by a vehicle. At the time of the original installation the Association opted to not have the mailbox posts mounted to the concrete bases, so the paint at the bottom of many of the posts have been damaged by string trimmers. Repainting of the posts and the mailboxes is included in the **Gazebo** category along with the metal fencing and entrance gates every six years.

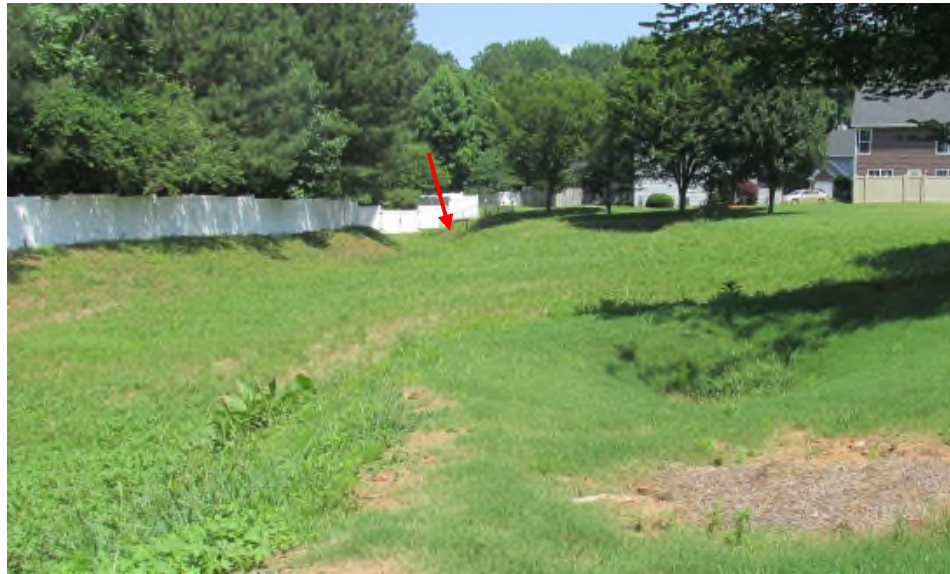
the collected rainwater is detained and then drains out at a set rate through the outlet structure. In between rains a detention pond is dry. In a retention pond system, the same amount of rainwater is collected and it drains out at the same rate, but a large amount of water is retained. There is one detention pond at The Gates of Bouldercrest that receives the stormwater collected by the curb inlets along the streets. There is also a large low-lying area in the southwest corner (seen in the next photo) that collects surface run-off from the south side of the property and directs the water into the detention pond but it does not detain any water so it is not a detention pond.

There is no inlet structure or outlet structure in that area but there is a normal drain at the low end of this area (the location is indicated by the red arrows in the previous and next photos) that collects the stormwater and then pipes it into the detention pond. The next photo shows a closer view of that drain just outside of one of the gates into the detention pond.

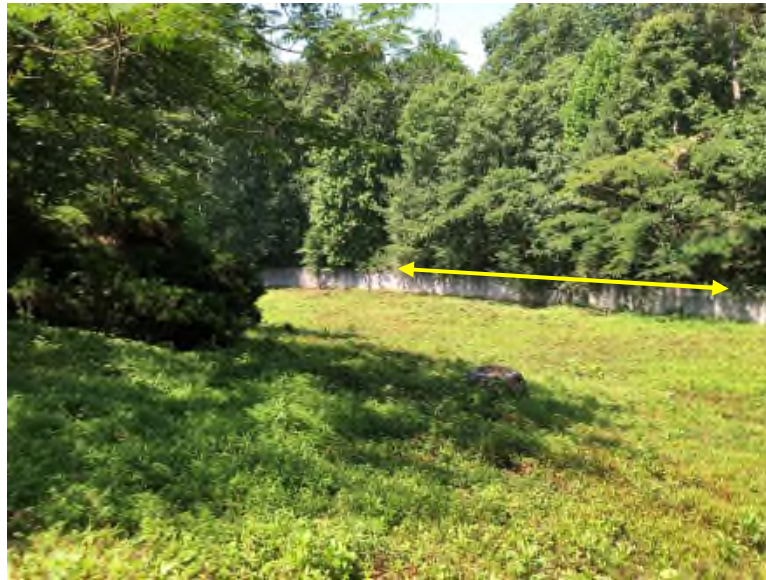
The interior of the detention pond can be seen in the next photo. Each county or city is obligated

with inspecting detention ponds within their jurisdiction. Some governmental authorities are more aggressive in their approach and the standard to which Associations are held may vary from place to place. Proper maintenance of a detention pond includes regular removal of all trees in the bottom of the pond, up the sides to about 10 feet above the pond floor. Keeping the pond vegetation under control annually is an operating expense and should be done when it can be accomplished, typically by your landscaper, with the type of equipment they use. The detention pond is being properly maintained. The yellow arrow in the photo indicates the concrete wall at the low side of the pond that forms the dam that detains the stormwater.

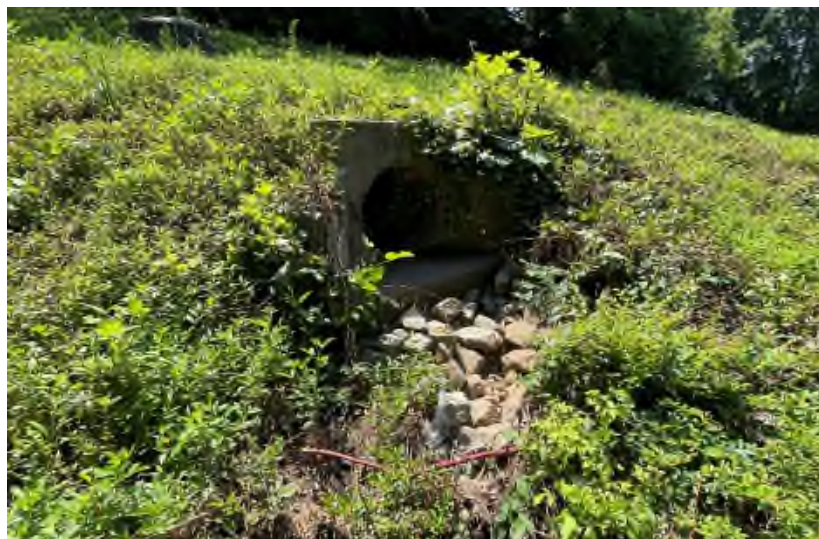
One of the inlets for the detention pond can be seen in the next photo. Note the large stone that absorbs the force of the waterflow to prevent erosion. The floor of the pond at the outlet is low enough so that water from the storm sewer system flows out completely from the pipes after the rain stops. These pipes are CMP (corrugated metal pipe) that can have a life of 50 to 75 years if they are dry between rains, but the life is diminished if they retain water.
